Manhole Inspection Summary

Manhole # S13UU1003MH

Insp Date: **4/10/07 10:38 AM**

Location Address: **BELVEDERE AVE**

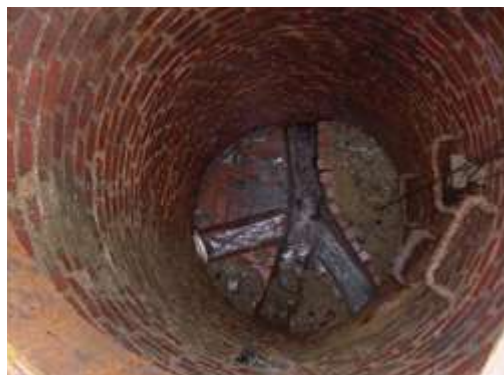
Top View

Corroded steps. Bench debris.

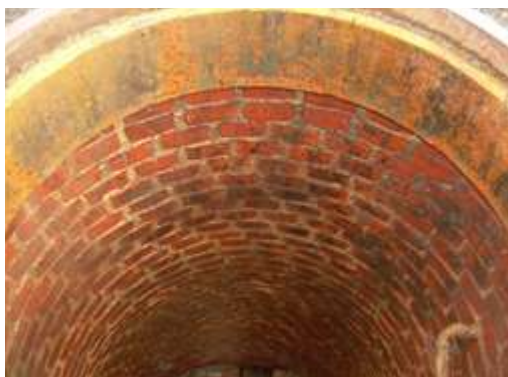
Defect

Adjustment, Corbel and Barrel infiltration.

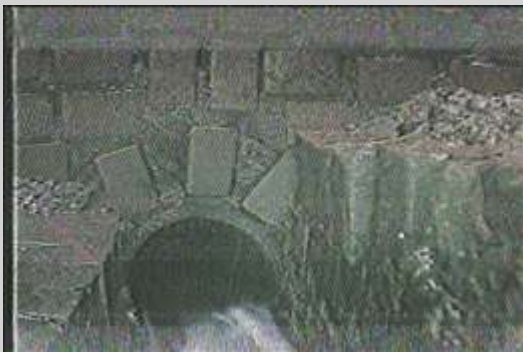
8 in. Circular Gravity Sewer Pipe Out @ 12 O'Clock

Barrel deterioration and infiltration.

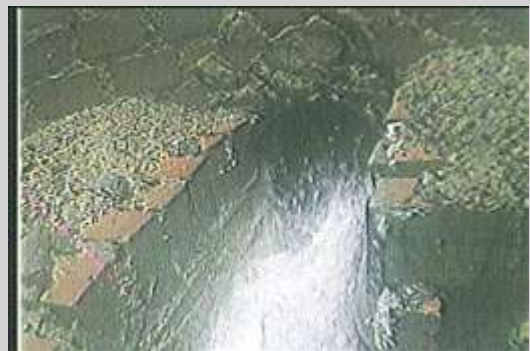
Drop In @ 5 O'Clock

Barrel deterioration and infiltration. Bench and Channel deterioration.

Drop Condition: **Open**

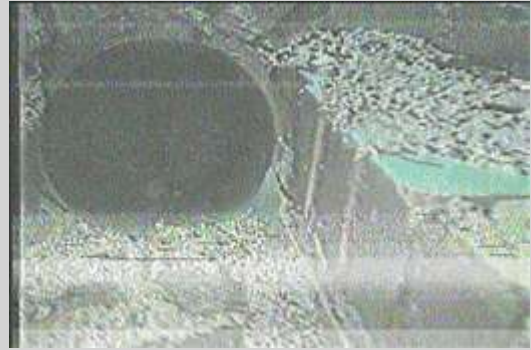
Drop In @ 6 O'Clock

Drop: **Outside** Rod and Bar
Angled: **Yes** Reading: **9.26** (ft.)
Inv Depth: **10.26** (ft.)
Drop Condition: **Clogged**
